INSTRUCTION FOR DAMAGED DATWYLER TUNNEL SEGMENT GASKETS

Repair Guideline for Datwyler elastomeric sealing gaskets This guide line describes the procedure for an already installed sealing gasket that has been damaged mechanically. In order to avoid leakage in the tunnel a repair has to be done.

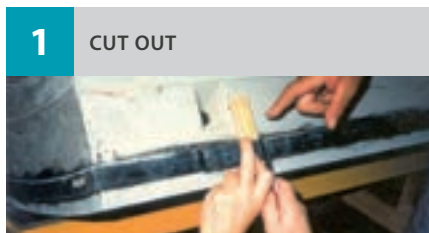
Cut out the damaged gasket area carefully by means of a sharp knife. Clean the cut area of loose adhesive.

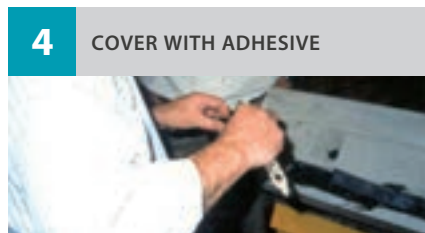
Apply adhesive to the segment groove and as well as to the bottom and side walls of the new gasket piece.

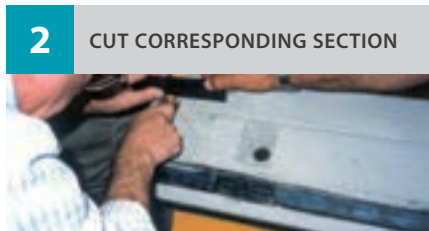
A corresponding section of that profile in perfect condition has to be cut to length. In order to achieve a good fit, the new profile piece has to be approximately 2% longer.

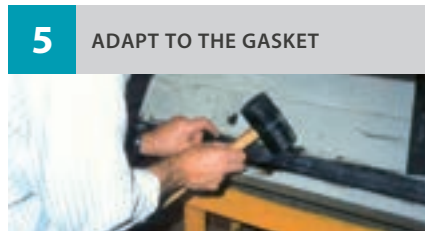
Insert the new profile piece into the cut section.

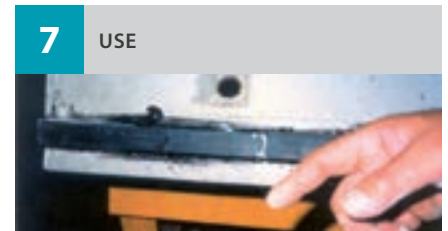
The gasket thus repaired can now be used.
